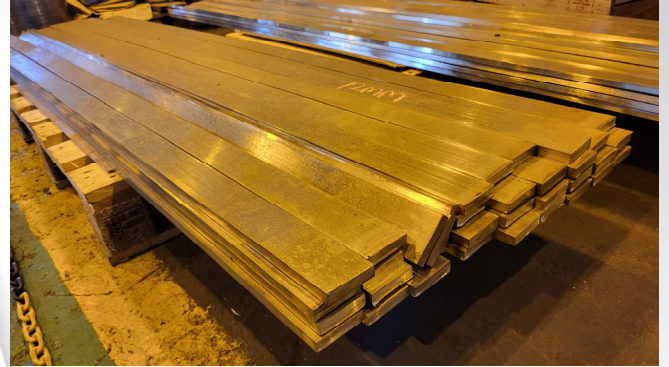
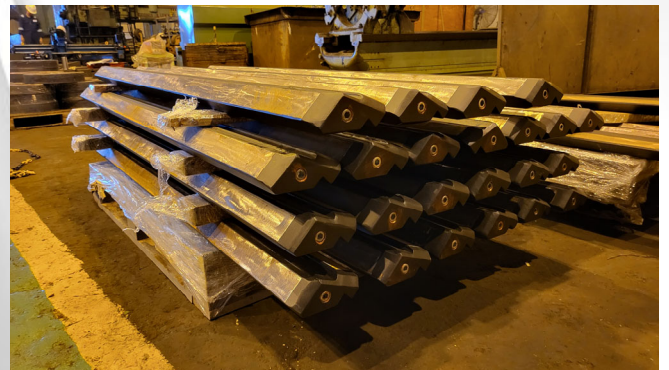
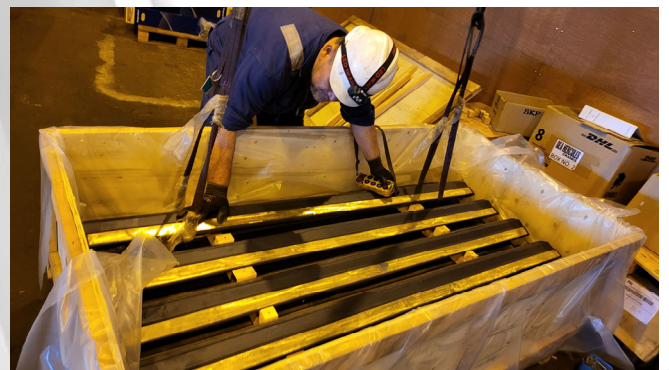
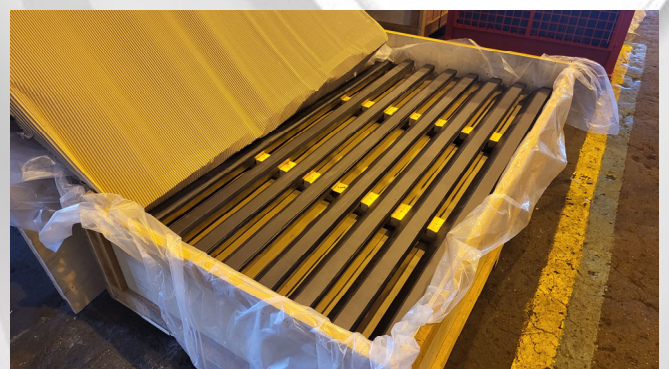
Our expertise has identified several root causes of common leg guide cracks and failures:

- Poor weld bonding on the wear plate.
- Insufficient welding strength on the wear plate.
- Interference with the leg chord.

To address these challenges, we have implemented the following enhancements:

- Re-engineered the welding procedure and material selection to improve bonding strength.
- Increased the volume of welding by 60%.
- Redesigned the wear plate position to avoid potential interference.
